Using Perfluorocarbon Tracers (PFT) for detecting oil leakages in LPOF cable systems

J.C.M. VAN ROSSUM*
Prysmian Group NL
The Netherlands

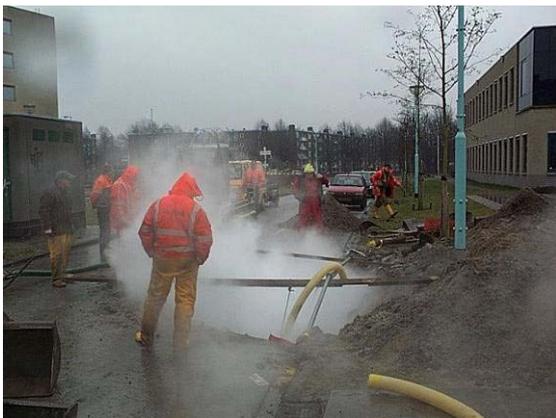
Photo 1 'freezing of 36/50kV fluid filled cable in urban area'

Traditionally the main method for locating cable fluid leaks has involved de-energizing of the cable circuit, excavation to gain access and then applying a liquid nitrogen freeze (photo 1).

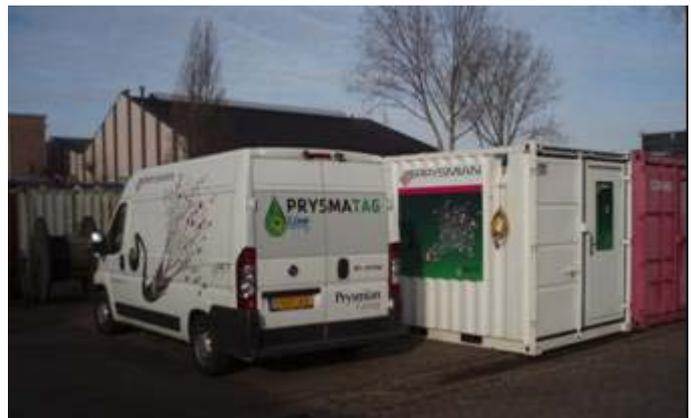
photo 2 'Equipment for injecting PFT in LPOF system during service'

For now there are two methods of injection available, being the “full flush” method and the “PFT injection during service” (photo 2). When the “full-flush” method is applied, the cable circuit is de-energized and the pressure tanks are closed. The free cable fluid is then flushed with PFT cable fluid. This is the quickest way to tag a cable circuit. With the “PFT injection during service” method a cable circuit is injected with an extra high concentration of PFT cable fluid during routine maintenance. This method can take a number of injection’s before the PFT Tracers reach the cable leak depending on the location of the leak in relation to the distance from the injection valve and the leak rate. A new, more efficient, method for injecting PFT cable fluid is under development in cooperation with one of the largest utilities of the Netherlands “Alliander”, see chapter 4.

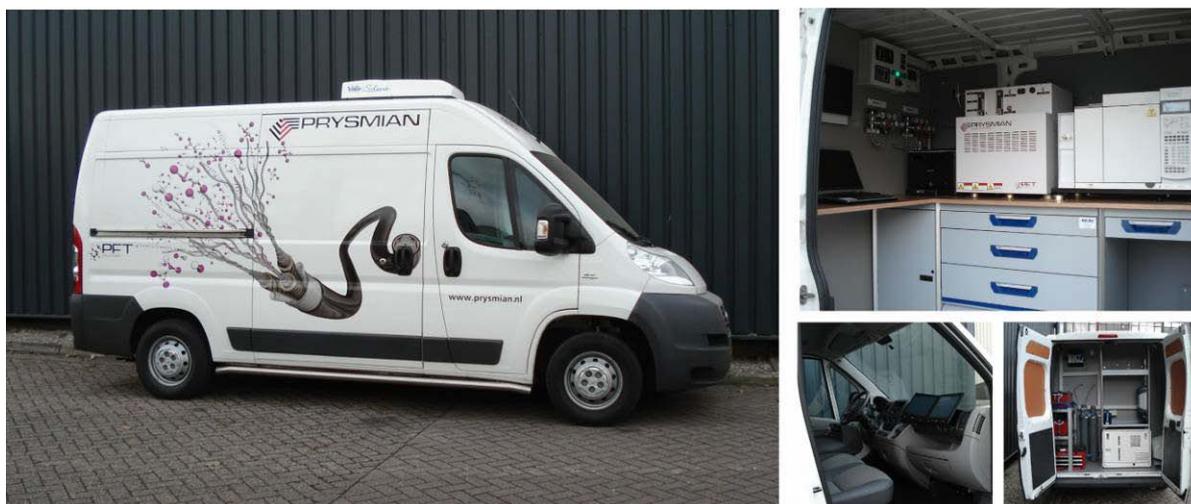
Photo 3 'PFT mobile laboratory for detecting small quantities of PFT in the atmosphere'

Perfluorocarbons are a man-made substance which are present in the atmosphere at very low background levels, typically 2-3 parts per quadrillion (ppq). An advanced mobile laboratory (photo 3) has developed which can detect the background levels of perfluorocarbon in the atmosphere.

Upon arrival at site the air over the cable route is sampled (when possible) by driving along the cable route or by handheld sampler. Any PFT which has permeated through the subsoil from the leaking cable fluid will be detected. When a high level of PFT is identified by the PFT van, a handheld sampler is used to pin point the location within one-two metres of the cable leak.

One remarkable result was found on a pilot project on a 150kV LPOF cable system. This circuit was leaking oil at a slow leakage rate: 18 ltr per week. Detection was initiated, using Prysmian detection van, see photo 3, but no leakages were found along the cable route.

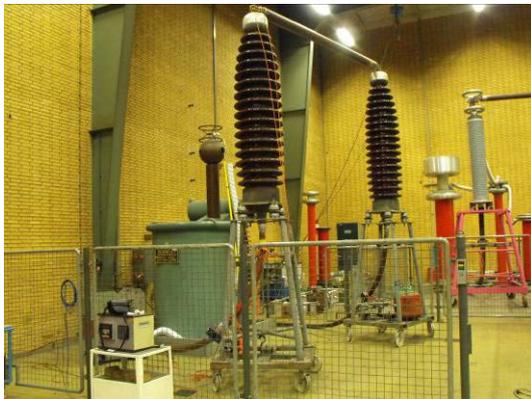
Photo 4 '87/150kV LPOF cable injected with PFT type test loop'

In order to demonstrate the compatibility of PFT with HV LPOF cable system technology, a type test at 87/150kV level was initiated. For this, 30 m of 87/150kV fluid filled cable, with 800 mm² Cu conductor and lead sheath, was installed with one 180° bend and terminated into porcelain outdoor terminations. The tested cable was produced and installed in 1969 and was in service for almost 40 years.

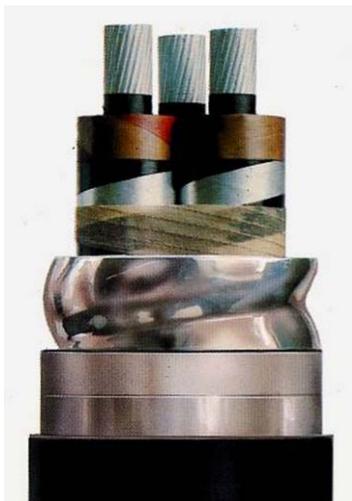
Photo 5 'example 36/50kV 3core LPOF cable'

The PFT pilot project is implemented in the 50kV grid of Alliander (Dutch DSO): in their 50kV grid a total of 1000 km three core LPOF cable is still in active service installed from the 1950's until the late 70's. A picture of a typical three core LPOF cable is shown in photo 5.

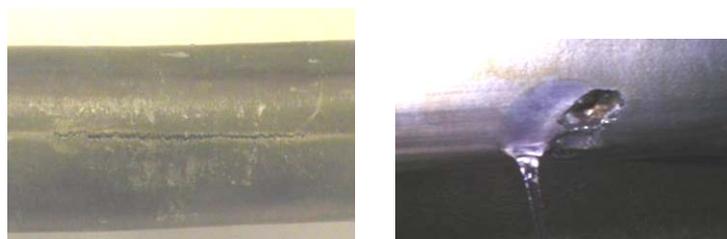
Photo 6 'typical defects of lead sheathed LPOF cables after ageing'

Small leakages (<5ltr/day) are non-detectable with traditional freezing methods, therefore a new strategy with the use of PFT technology was adapted by Alliander. After careful considerations the pilot project was initiated on four cable oil sections. Relevant data may be found in table 1. These four sections have leakage history over the last decade with non-detectable cause. See photo 6 for typical leaking defects that can occur in LPOF cable lead sheath due to fatigue.

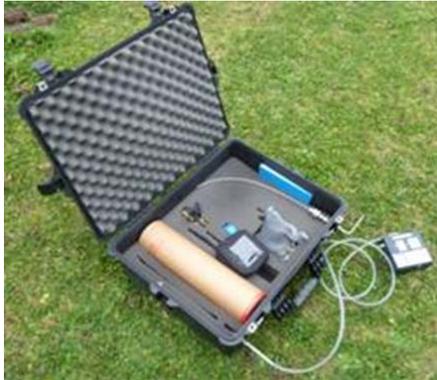
Photo 7 'hand held PFT sampler'

Eventually, with the aid of the hand-held PFT sampler (see photo 7), the leakage was detected in an oil feeding pipe between a pressure tank and LPOF joint connected to a 150kV LPOF spare cable, despite the fact that:
